## INSPECTION

### 1. PRETENSIONER IS NOT ACTIVATED

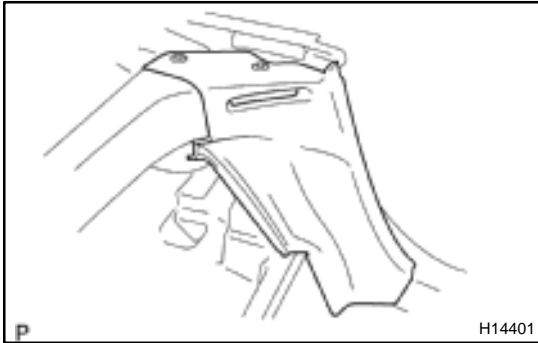
- (b) Perform a visual check which includes the following items with the front seat outer belt removed from the vehicle.
- Check for cuts and cracks in, or marked discoloration on the quarter trim panel.
  - Check for cuts and cracks in wire harness, and for chipping in connectors.
  - Check for deformation of the center floor No. 3 crossmember.
