NEDN-03

CIRCUIT DESCRIPTION

2000 MR2 (RM760U)

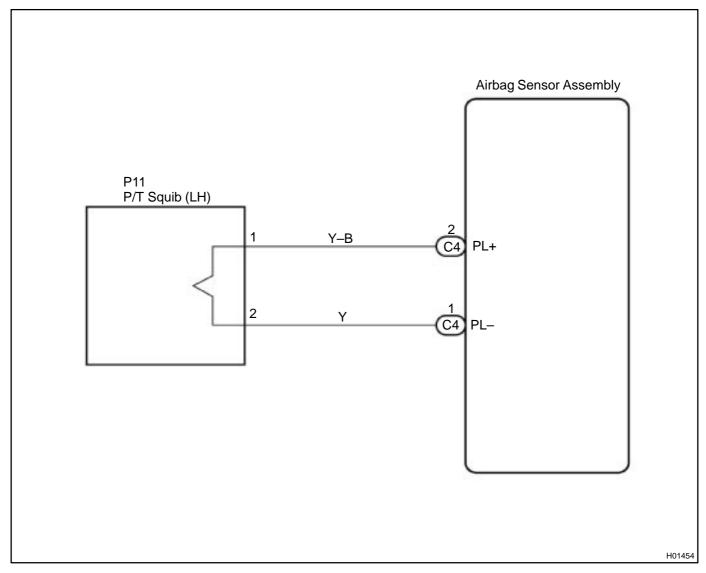
WIRING DIAGRAM

The P/T squib (LH) circuit consists of the airbag sensor assembly and seat belt pretensioner (LH). It causes the SRS to deploy when the SRS deployment conditions are satisfied. For details of the function of each component, see OPERATION on page RS-2. DTC B0135/73 is recorded when a short is detected in the P/T squib (LH) circuit.

For the connector (on the seat belt pretensioner side) between the seat belt pretensioner (LH) and the airbag sensor assembly, measure the resistance between terminals PL+ and PL-.

Resistance: 1 M Ω or Higher

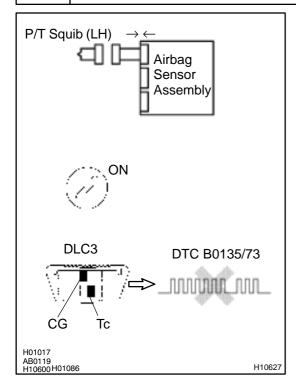
Check airbag sensor assembly.

PREPARATION:

- (a) Connect the connector to the airbag sensor assembly.
- (b) Connect the negative (–) terminal cable to the battery, and wait at least for 2 seconds.

- (a) Turn the ignition switch ON, and wait at least for 20 seconds.
- (b) Clear the DTC stored in memory (See page DI-237).
- (c) Turn the ignition switch to LOCK, and wait at least for 20 seconds.
- (d) Turn the ignition switch ON, and wait at least for 20 seconds.
- (e) Check the DTC (See page DI-237).

DTC B0135/73 is not output.

Replace airbag sensor assembly.

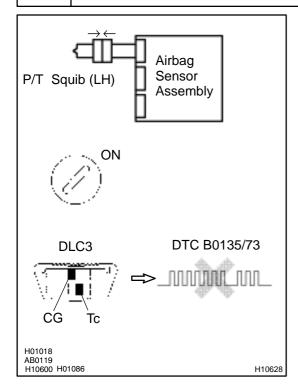
4 Check P/T squib (LH).

- (a) Turn the ignition switch to LOCK.
- (b) Disconnect negative (–) terminal cable from the battery, and wait at least for 90 seconds.
- (c) Connect the seat belt pretensioner (LH) connector.
- (d) Connect the negative (–) terminal cable to the battery, and wait at least for 2 seconds.

- (a) Turn the ignition switch to LOOK, and wait at least for 20 second.
- (b) Turn the ignition switch ON, and wait at least for 20 seconds.
- (c) Clear the DTC stored in memory (See page DI-237).
- (d) Turn the ignition switch to LOCK, and wait at least for 20 seconds.
- (e) Turn the ignition switch ON, and wait at least for 20 seconds
- (f) Check the DTC (See page DI-237).

DTC B0135/73 is not output.

Replace seat belt pretensioner (LH).
