DTC	B0137/71	Short in P/T Squib (LH) Circuit (to Ground)
		(to Ground)

2000 MR2 (RM760U)

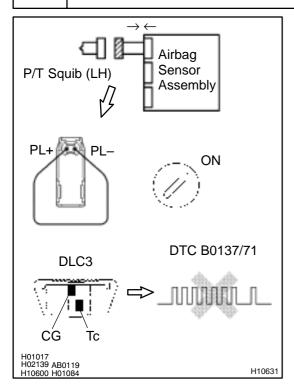
3

Check airbag sensor assembly.

- (a) Connect the connector to the airbag sensor assembly.
- (b) Using a service wire, connect terminals PL+ and PL- of the connector (on the seat belt pretensioner side) between the seat belt pretensioner (LH) and the airbag sensor assembly.
- (c) Connect the negative (–) terminal cable to the battery, and wait at least for 2 seconds.

- (a) Turn the ignition switch ON, and wait at least for 20 seconds.
- (b) Clear the DTC stored in memory (See step 5 on page DI-237).
- (c) Turn the ignition switch to LOCK, and wait at least for 20 seconds.
- (d) Turn the ignition switch ON, and wait at least for 20 seconds.
- (e) Check the DTC (See page DI-237).

DTC B0137/71 is not output.

Replace airbag sensor assembly.

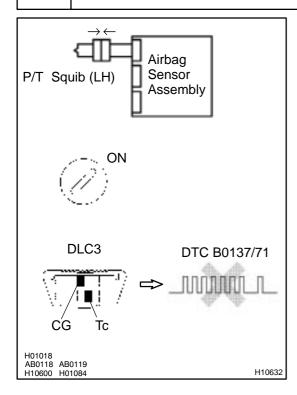
4 Check P/T squib (LH).

- (a) Turn the ignition switch to LOCK.
- (b) Disconnect the negative (–) terminal cable from the battery, and wait at least for 90 seconds.
- (c) Connect the seat belt pretensioner (LH) connector.
- (d) Connect the negative (–) terminal cable to the battery, and wait at least for 2 seconds.

- (a) Turn the ignition switch ON, and wait at least for 20 seconds
- (b) Clear the DTC stored in memory (See step 5 on page DI–237).
- (c) Turn the ignition switch to LOCK, and wait at least for 20 seconds.
- (d) Turn the ignition switch ON, and wait at least for 20 seconds.
- (e) Check the DTC (See page DI-237).

DTC B0137/71 is not output.

Replace seat belt pretensioner (LH).
