DI6PQ-02

DTC B0138/72 Short in P/T Squib (LH) Circuit (to B+)

2000 MR2 (RM760U)

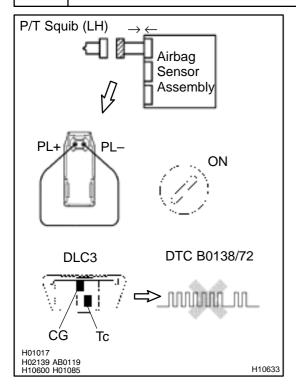
## Check airbag sensor assembly.

- (a) Connect the connector to the airbag sensor assembly.
- (b) Using a service wire, connect terminals PL+ and PL- of the connector (on the seat belt pretensioner side) between the seat belt pretensioner (LH) and the airbag sensor assembly.
- (c) Connect the negative (–) terminal cable to the battery, and wait at least for 2 seconds.

- (a) Turn the ignition switch ON, and wait at least for 20 seconds.
- (b) Clear the DTC stored in memory (See step 5 on page DI-237).
- (c) Turn the ignition switch to LOCK, and wait at least for 20 seconds.
- (d) Turn the ignition switch ON, and wait at least for 20 seconds
- (e) Check the DTC (See page DI-237).

## DTC B0138/72 is not output.

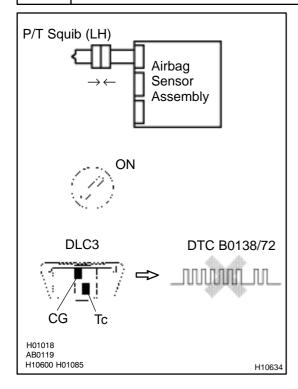
# 4 Check P/T squib (LH).

- (a) Turn the ignition switch to LOCK.
- (b) Disconnect the negative (–) terminal cable from the battery, and wait at least for 90 seconds.
- (c) Connect the seat belt pretensioner (LH) connector.
- (d) Connect the negative (–) terminal cable to the battery, and wait at least for 2 seconds.

- (a) Turn the ignition switch ON, and wait at least for 20 seconds.
- (b) Clear the DTC stored in memory (See step 5 on page DI–237).
- (c) Turn the ignition switch to LOCK, and wait at least for 20 seconds.
- (d) Turn the ignition switch ON, and wait at least for 20 seconds
- (e) Check the DTC (See page DI-237).

## DTC B0138/72 is not output.
