## INSPECTION

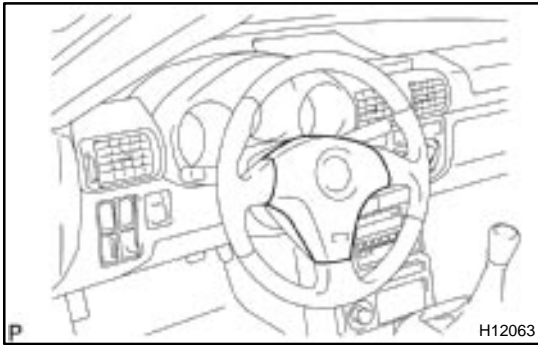
1. **Vehicle not involved in collision:**  
**INSPECT SUPPLEMENTAL RESTRAINT SYSTEM**
  - (a) Check a diagnostic system (See page [DI-237](#)).
  - (b) Do a visual check which includes the following item with the steering wheel pad (with airbag) installed in the vehicle.  
 Check cuts, minute cracks or marked discoloration on the steering wheel pad top surface and in the grooved portion.
2. **Vehicle involved in collision with airbag not deployed:**  
**INSPECT SUPPLEMENTAL RESTRAINT SYSTEM**
  - (a) Check a diagnostic system (See page [DI-237](#)).
