BO34V-01

# INSPECTION

2000 MR2 (RM760U)

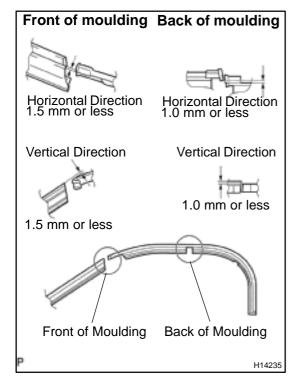
(a) Inspect the roof drip moulding gap.

### Standard gap:

-	Vertical direction	Horizontal direction
Frontmoulding	1.5 mm (0.059 in) or less	1.5 mm (0.059 in) or less
Rearmoulding	1.0 mm (0.039 in) or less	1.0 mm (0.039 in) or less

#### NOTICE:

In case that it is out of the standard range, adjust or replace the roof drip moulding.
