INSPECTION

1. INSPECT SYNCHRONIZER RING

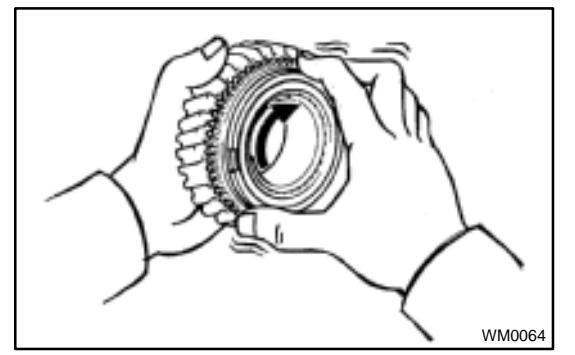
MX09M-02

- (a) Check for wear or damage.
- (b) Check the braking effect of the synchronizer ring. Turn the synchronizer ring in one direction while pushing it to the gear cone. Check that the ring locks.

If the braking effect is insufficient, apply a small amount of the fine lapping compound between the synchronizer ring and gear cone. Lightly rub the synchronizer ring and gear cone together. **NOTICE:**

(c) Check again the braking effect of the synchronizer ring.

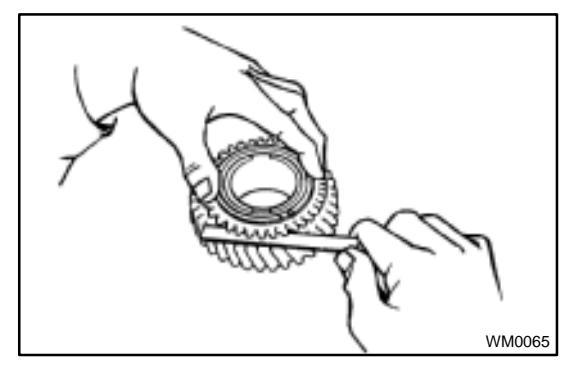
(d) Using a feeler gauge, measure the clearance between the synchronizer ring back and gear spline end.
Minimum clearance:
3rd gear: 0.65 mm (0.0256 in.)
4th gear: 0.75 mm (0.0295 in.)

If the clearance is less than the minimum, replace the synchronizer ring, and apply a small amount of the fine lapping compound on gear cone.

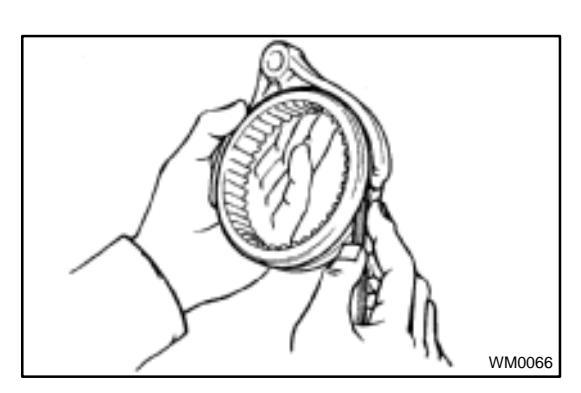
2. INSPECT NO. 2 GEAR SHIFT FORK AND NO. 2 HUB SLEEVE CLEARANCE

Using a feeler gauge, measure the clearance between the hub sleeve and gear shift fork.

Maximum clearance: 0.35 mm (0.014 in.)

If the clearance exceeds the maximum, replace the gear shift fork or hub sleeve.

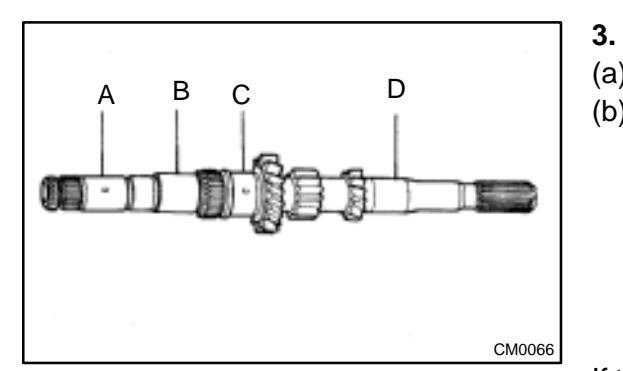
INSPECT INPUT SHAFT

- Check the input shaft for wear or damage. (a)
- (b) Using a micrometer, measure the outer diameter of the input shaft journal surface.

Minimum outer diameter:

- Part A: 24.885 mm (0.9797 in.)
- Part B: 28.985 mm (1.1411 in.)
- Part C: 30.985 mm (1.2199 in.)

Part D: 24.985 mm (0.9837 in.)

If the outer diameter is less than the minimum, replace the input shaft.

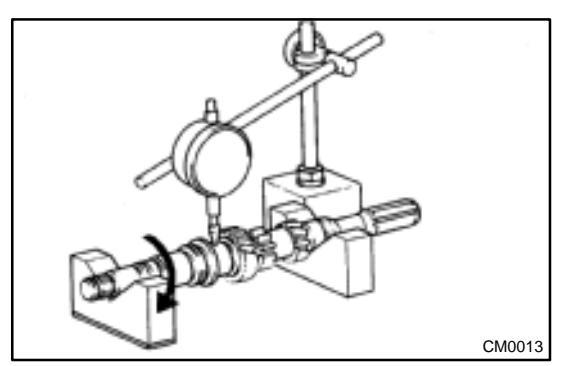
(C) Using a dial indicator, check the shaft runout. Maximum runout: 0.03 mm (0.0012 in.)

If the runout exceeds the maximum, replace the input shaft.
