DI6P3-03

CIRCUIT INSPECTION

DTC	B0100/13	Short in D Squib Circuit
-----	----------	--------------------------

2000 MR2 (RM760U)

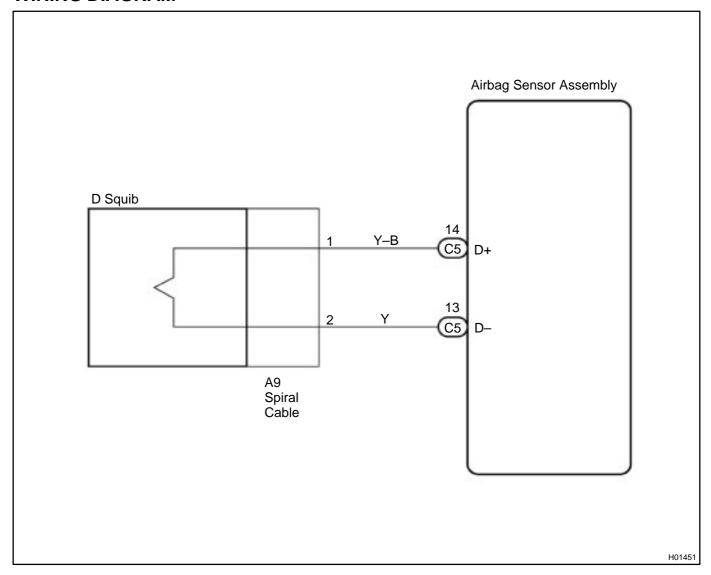
WIRING DIAGRAM

The D squib circuit consists of the airbag sensor assembly, spiral cable and steering wheel pad. It causes the airbag to deploy when the airbag deployment conditions are satisfied. For details of the function of each component, see OPERATION on page RS-2. DTC B0100/13 is recorded when a short is detected in the D squib circuit.

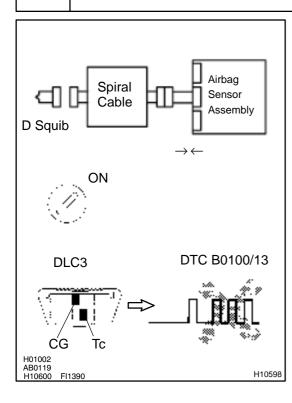
3 Check airbag sensor assembly.

PREPARATION:

- (a) Connect the connector to the airbag sensor assembly.
- (b) Connect the negative (–) terminal cable to the battery, and wait at least for 2 seconds.

CHECK:

- (a) Turn the ignition switch ON, and wait at least for 20 seconds.
- (b) Clear the DTC stored in memory (See page DI-237).
- (c) Turn the ignition switch to LOCK, and wait at least for 20 seconds.
- (d) Turn the ignition switch ON, and wait at least for 20 seconds.
- (e) Check the DTC (See page DI-237).

OK:

DTC B0100/13 is not output.

Replace airbag sensor assembly.

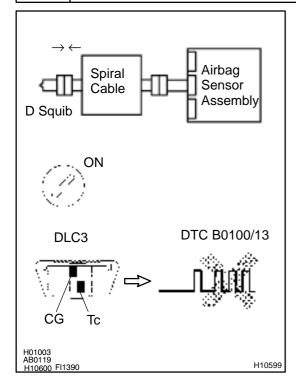
4 Check D squib.

PREPARATION:

- (a) Turn the ignition switch to LOCK.
- (b) Disconnect the negative (–) terminal cable from the battery, and wait at least for 90 seconds.
- (c) Connect the steering wheel pad connector.
- (d) Connect the negative (–) terminal cable to the battery, and wait at least for 2 seconds.

CHECK:

- (a) Turn the ignition switch to LOCK, and wait at least for 20 seconds.
- (b) Turn the ignition switch ON, and wait at least for 20 seconds.
- (c) Clear the DTC stored in memory (See page DI-237).
- (d) Turn the ignition switch to LOCK, and wait at least for 20 seconds.
- (e) Turn the ignition switch ON, and wait at least for 20 seconds.
- (f) Check the DTC (See page DI-237).

OK:

DTC B0100/13 is not output.

Replace steering wheel pad.
